PAVEMENT CONDITION ASSESSMENT

TOWN OF MEAD

June 2020

Kimley»Horn

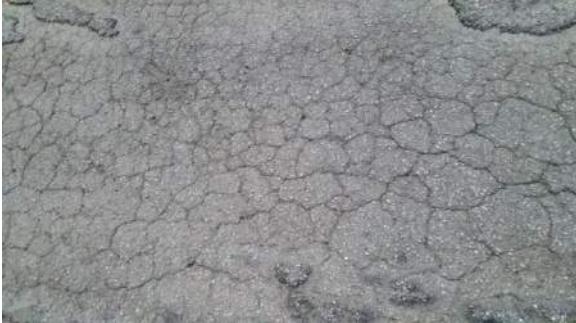
<p>Alligator (fatigue) cracking is a series of interconnecting cracks caused by fatigue failure of the asphalt concrete surface under repeated traffic loading. Cracking typically begins at the bottom of the bound pavement layer where tensile stresses and strains are the highest under wheel loading. The cracks propagate to the surface and begin to resemble the skin of an alligator. Alligator cracking is a major structural distress and is often accompanied by rutting. More significant treatments such as mill-and-overlay or full-depth reconstruction are required to adequately address alligator cracking.</p>

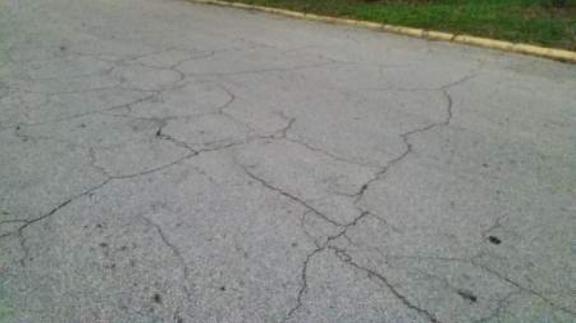
<p>Block cracking is represented by interconnected cracks that form large, uniform rectangular pieces. It is induced by changes in temperature as the pavement surface expands in hotter temperatures and contracts in colder temperatures. The pavement surface cracks uniformly to relieve the build-up of thermal stress. Block cracking usually occurs over a large area and may be present throughout an entire section. Its presence indicates a hardening of the asphalt binder and reduced elasticity.</p>

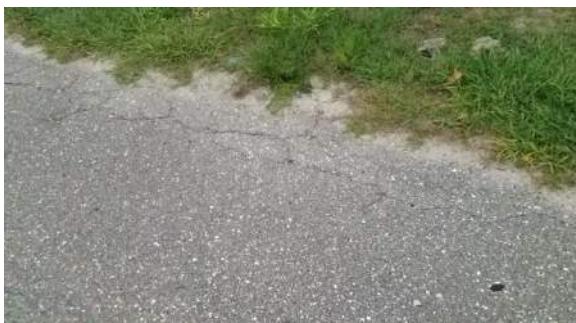
<p>Edge cracking occurs parallel to the edge of pavement and is typically located within 1 to 1.5 m of the shoulder. Edge cracking is accelerated by traffic loading and can be caused by weakening of the base or subgrade layers near the pavement edge. Edge cracking is only rated when the shoulder is unpaved and there is no curb or gutter present.</p>

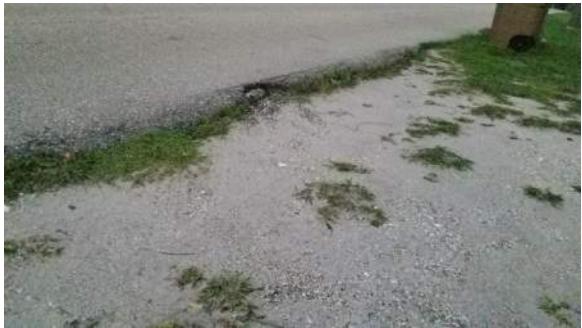
<p>Lane-shoulder drop-off is a difference in elevation between the pavement edge and the shoulder. It is caused by shoulder erosion, shoulder settlement, or by building up the pavement without adjusting the shoulder level.</p>

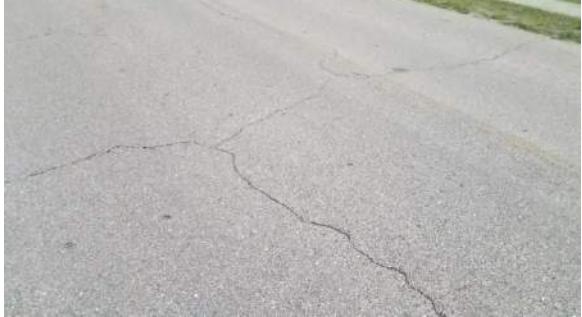
<p>Longitudinal and transverse cracking occurs parallel or perpendicular, respectively, to the roadway centerline.</p> <p>Longitudinal cracks typically arise due to a poorly constructed paving joint or contraction of the pavement surface due to temperature changes.</p> <p>Transverse cracks extend across the width of the roadway and result from daily temperature cycling. They are not typically load-related.</p>

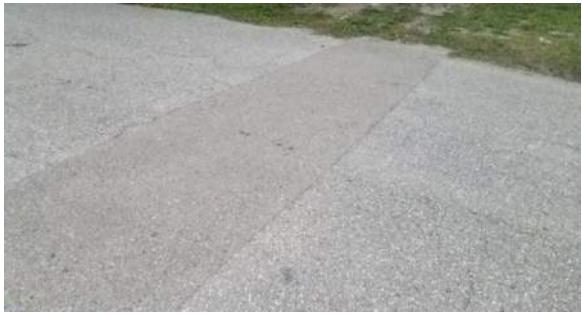
<p>Patching and utility cuts are areas in which the original pavement has been partially removed and replaced.</p> <p>Patching often results from subsurface water or utility work, or as a remedy to other surface distresses such as alligator cracking or potholes. A patch is considered a pavement defect no matter the size or condition of the patched area.</p>

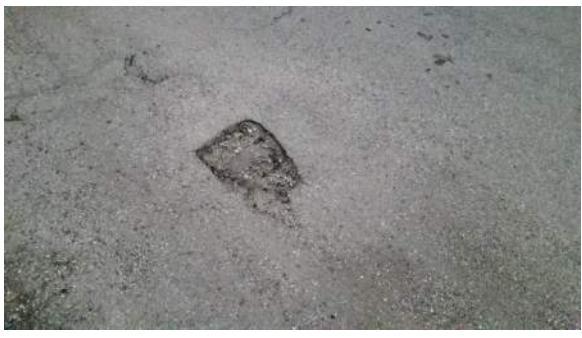
<p>Potholes are small, bowl-shaped depressions in the pavement surface and are characterized by sharp edges at the surface. Their growth is accelerated by free moisture collection inside the hole.</p> <p>Potholes are produced when localized areas in subsurface layers have deteriorated or as a progression from high-severity alligator cracking. Potholes represent structurally deficient areas in the pavement.</p>

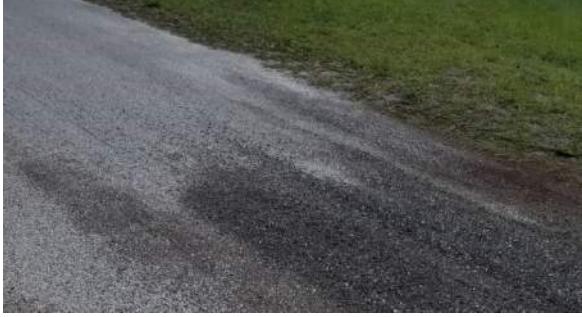
<p>Raveling is the dislodging of coarse aggregate particles from the pavement surface due to a loss of bond between the asphalt binder and aggregate particle. Raveling may be caused due to aggregate segregation, inadequate compaction during construction, or mechanical dislodging due to certain types of traffic.</p>

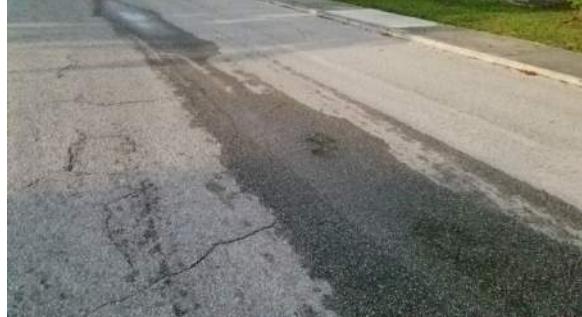
<p>Rutting appears as a depression in the wheel path and is a structural defect resulting from traffic loading. In some instances, rutting is most noticeable after a rain event when water pools at the bottom of the rut and creates dangerous hydroplaning conditions.</p> <p>Rutting results from permanent deformation of either the bound or unbound pavement layers. Static traffic loading and turning movements in hot weather can increase the likelihood of rutting given the higher viscosity of the asphalt binder. Rutting is a major structural distress that requires extensive rehabilitation to correct.</p>
