PAVEMENT CONDITION ASSESSMENT

TOWN OF MEAD

June 2020

Kimley»Horn

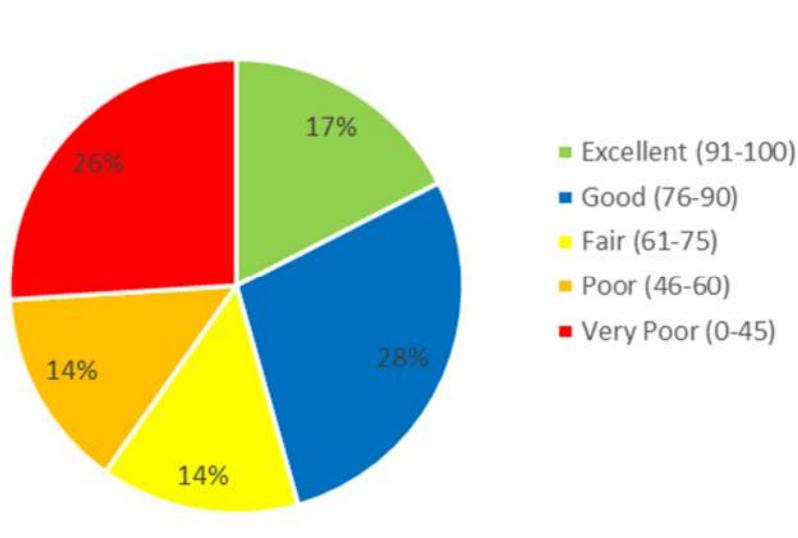
Figure 2. Pavement Condition Distribution

As of February 2020, PCI results indicate the Town of Mead's roadway network is in *Fair* condition with an overall PCI value of 67. The distribution of conditions is shown in **Figure 2** below.

Approximately 45% of roadways are in *Good* or better condition, and 59% of roadways are *Fair* or better. *Very Poor* roadways comprise approximately 26% of the Mead network. This distribution of conditions is relatively well-balanced across condition categories, suggesting that a range of M&R treatment options is appropriate to remedy present deficiencies.

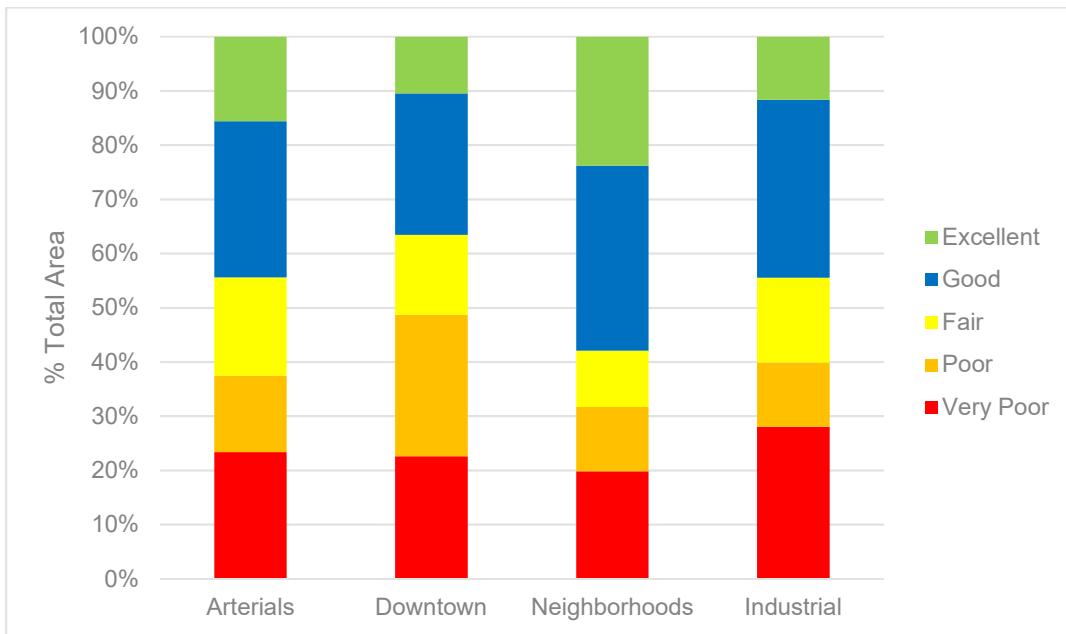
Figure 3. Pavement Condition Distribution by Rank

In implementing this pavement maintenance plan, the roadway network is divided into four pavement ranks based upon usage: arterials, downtown streets, industrial streets, and residential neighborhoods. The arterials are identified as the most critical thoroughfares in the Town and receive the highest priority when assigning M&R work over the 5-year planning period. Downtown, industrial, and neighborhood streets typically receive less traffic and are prioritized lower in the project selection process. **Table 1** contains summary information by pavement rank, while **Figure 3** shows the network condition distribution by rank.

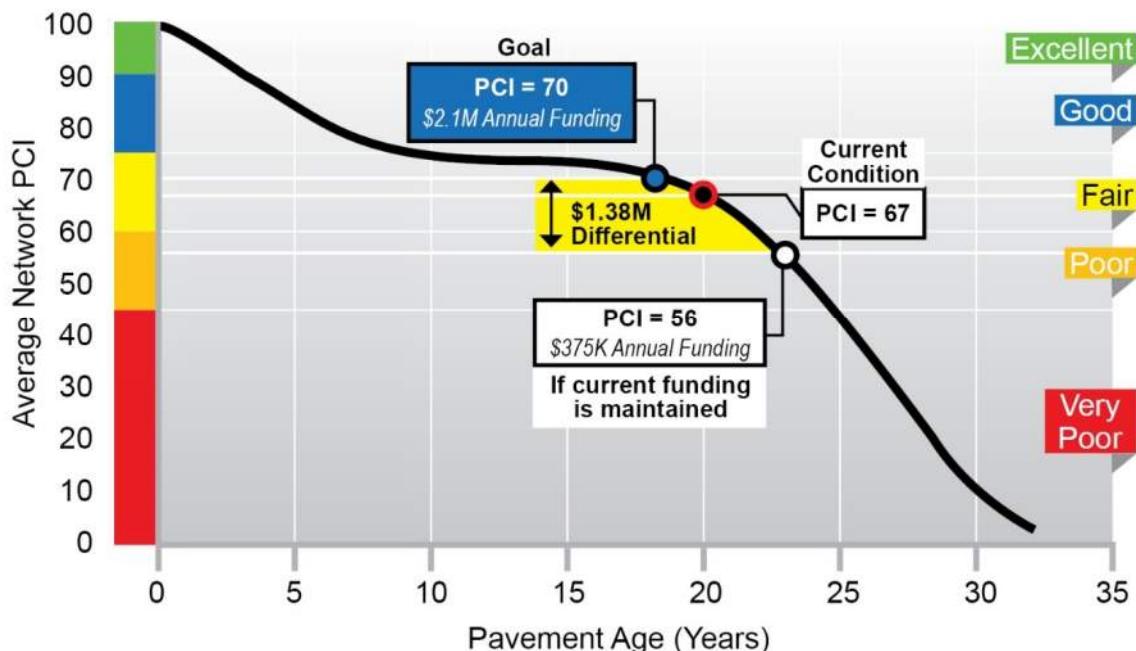
Figure 6. Town of Mead Road System Deterioration Curve

Figure 6 shows the deterioration curve of the Town's road system. As can be seen, the Town's road system is at the critical point on the deterioration curve where the condition will start degrading rapidly, with repair costs significantly increasing. Without significant investments in roadway improvements, ongoing deterioration across the network is expected. Annual funding levels of \$1.8 million are expected to result in 2024 network-level conditions on par with current conditions with an average PCI of 67. Funding at the current rate of \$375,000 annually is expected to result in a gradual decline in overall conditions to an average PCI of 56. Conversely, funding at \$2.1 million annually is expected to improve conditions to an average PCI of 70.
